3.6.6: Block 39 Lot 4

6.6: Block 39 Lot 4

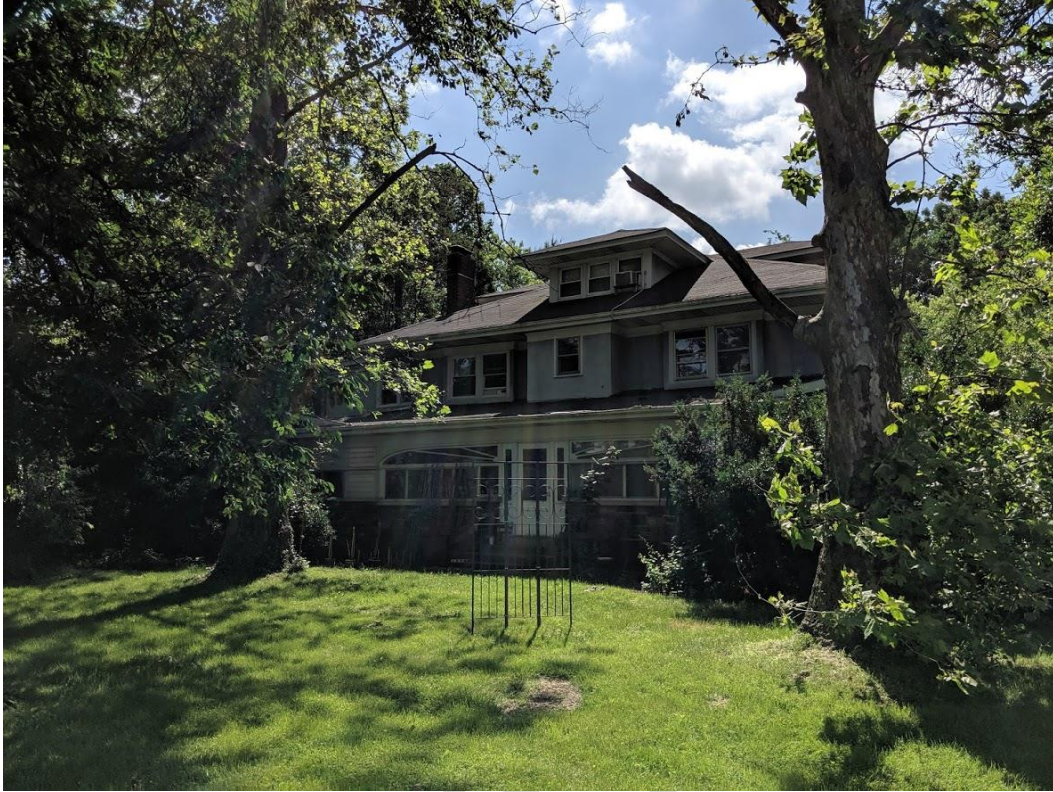
Photograph 22: Block 39 Lot 4 Front Façade of Building

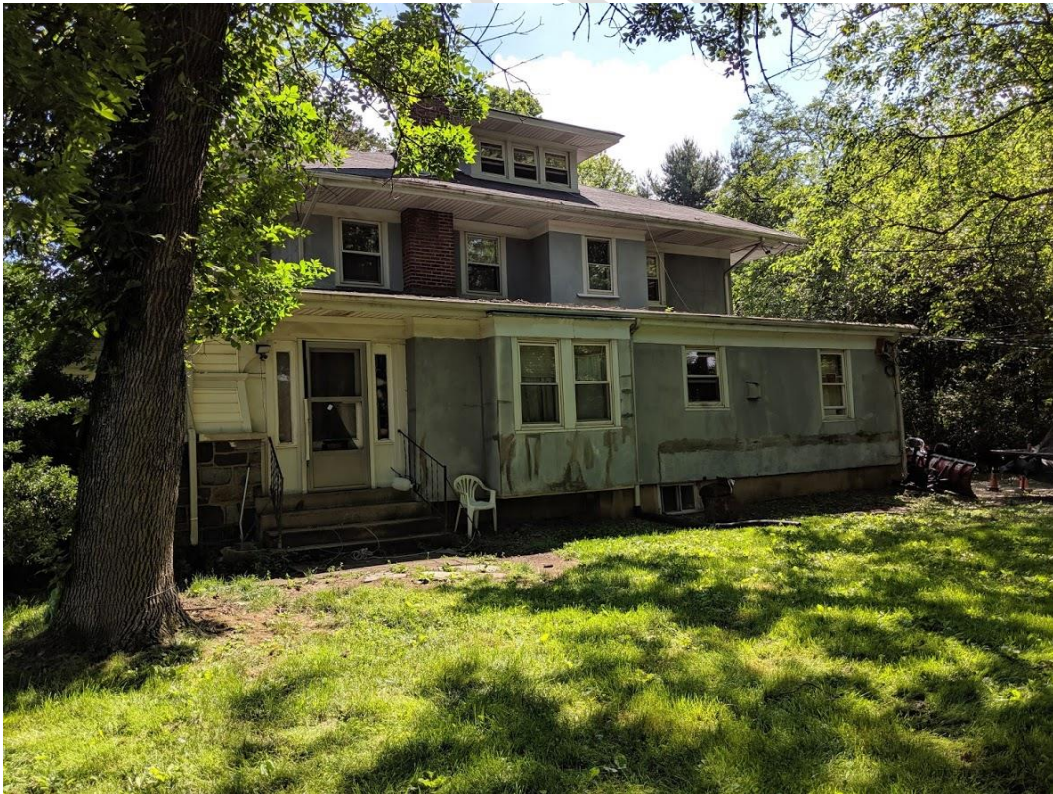
Photograph 23: Block 39 Lot 4 Southwesterly Side Façade of Building

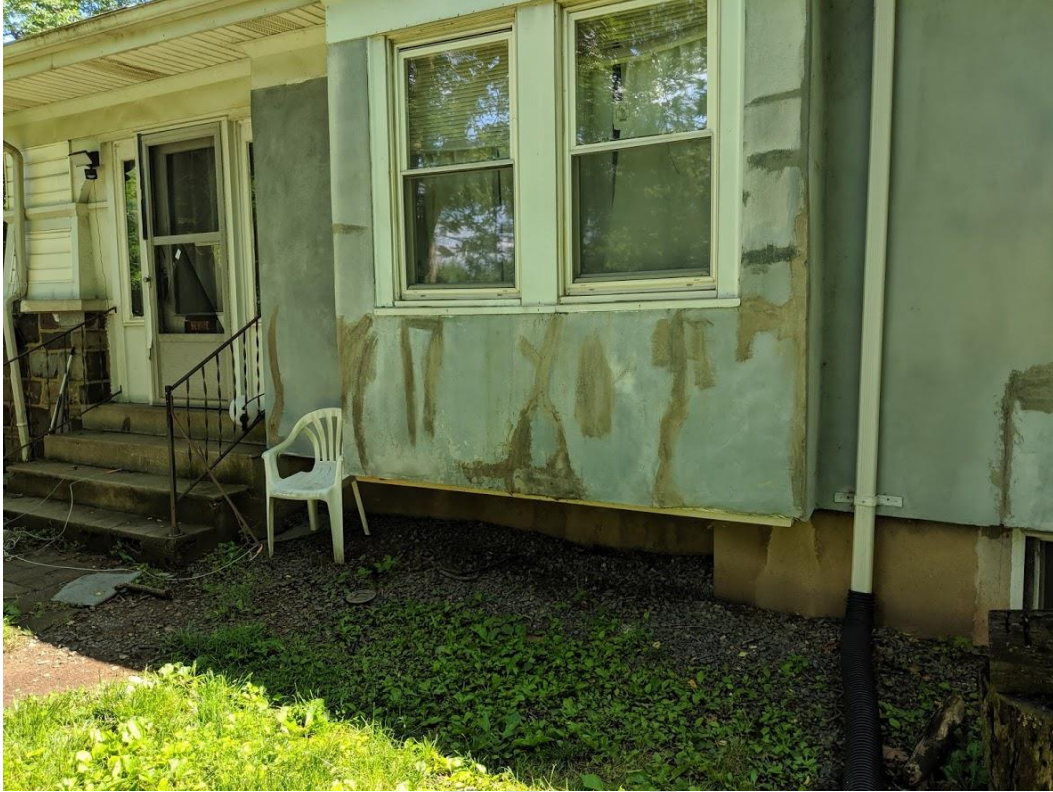
Date	Department	Complaint/Issue	Description
03/17/99	N/A	Letter from Tenants	<p>Complaints focused on:</p> <ul style="list-style-type: none"> Construction resulting in large exterior cracks, reaching from the base of apartment 2 to the top of apartment floor. Cement used to cover these cracks, but it too is now cracking. In addition, extensive cracks have appeared on the interior walls . Disruption of service including hot/cold water, gas, phone, cable Construction beginning before 8:00 am
03/18/99	Construction	N.J.A.C. 5:23-214.(a) Work Performed Without a Permit	Owner/Agent has conformed with requirements, all outstanding penalties satisfied
03/23/99	Construction	Violation of N.J.A.C. 5:23-2.14(A) Worked Performed Without Required Permit	In regard to tanks. Owner/Agent has conformed with requirements, all outstanding penalties satisfied

Photograph 24: Block 39 Lot 4 Southwesterly Side Façade of Building (showing patchwork of cracks)

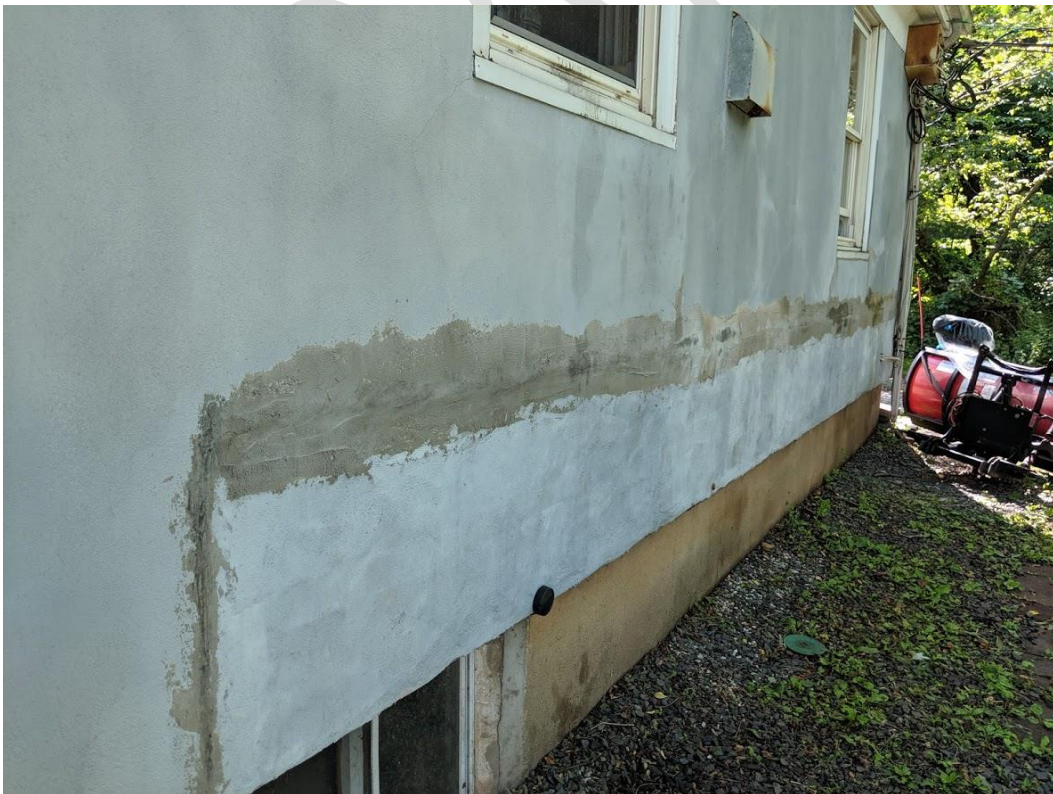
Photograph 25: Block 39 Lot 4 Southwesterly Side Façade of Building (showing patchwork of cracks)

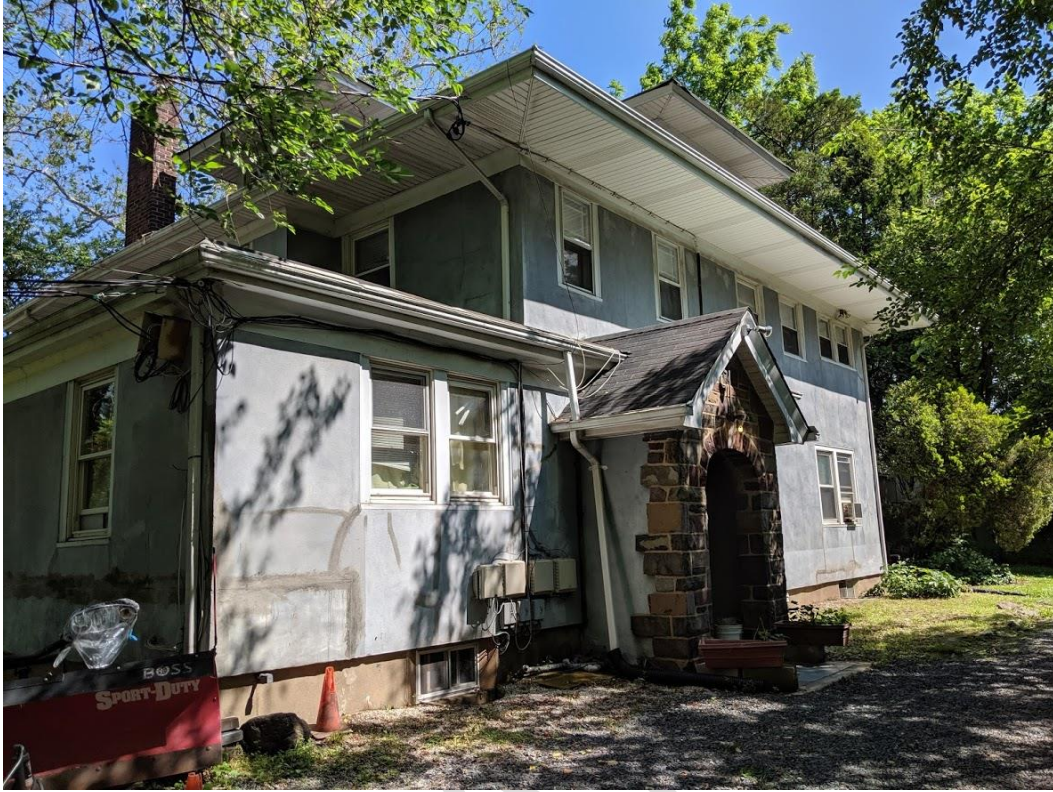
Photograph 26: Block 39 Lot 4 Rear Façade of Building

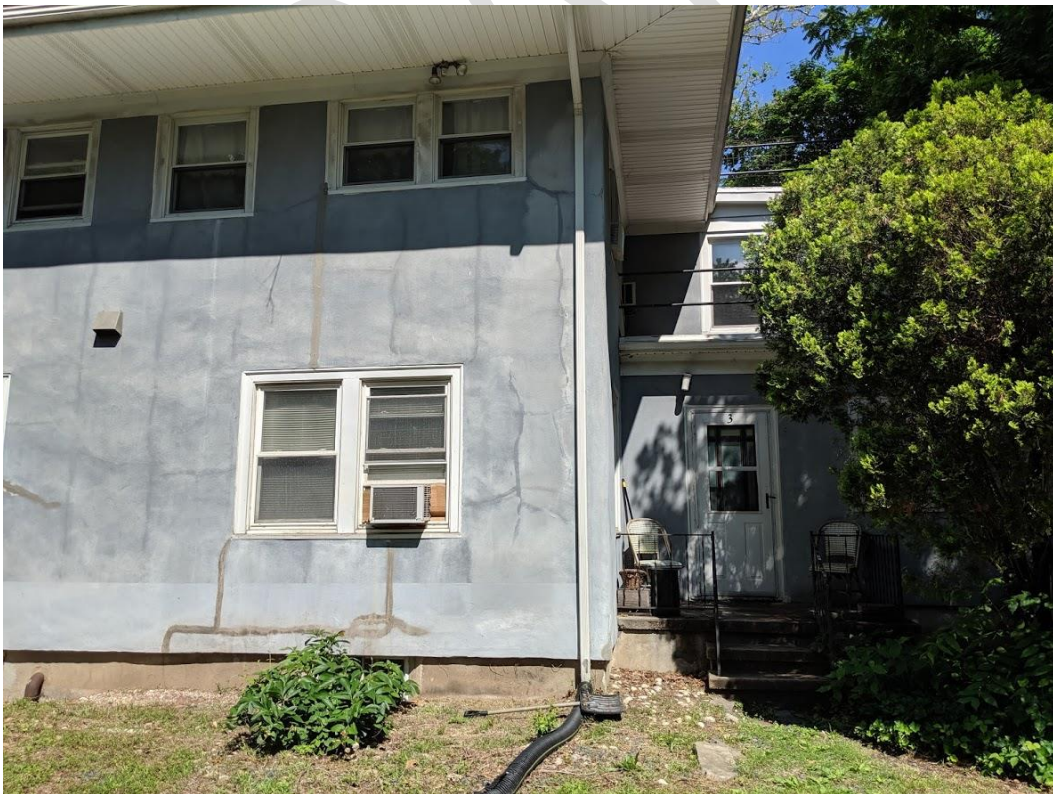
Photograph 27: Block 39 Lot 4 Rear Façade of Building

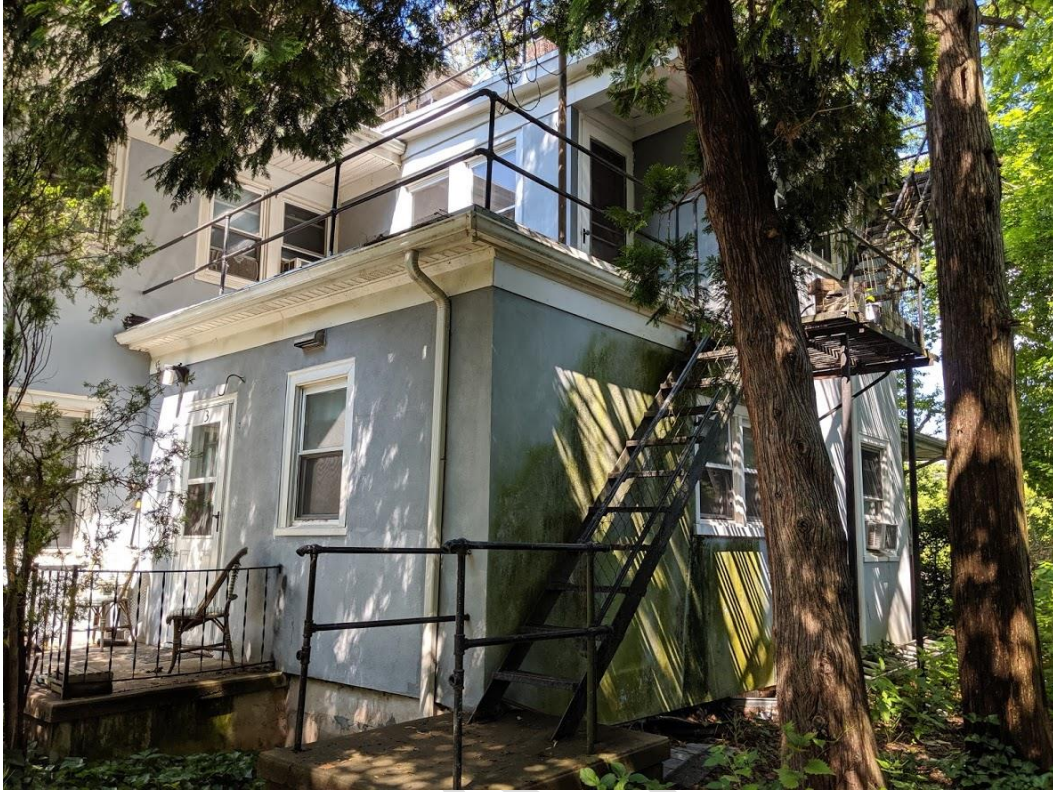
Photograph 28: Block 39 Lot 4 Northeastly Side Façade of Building

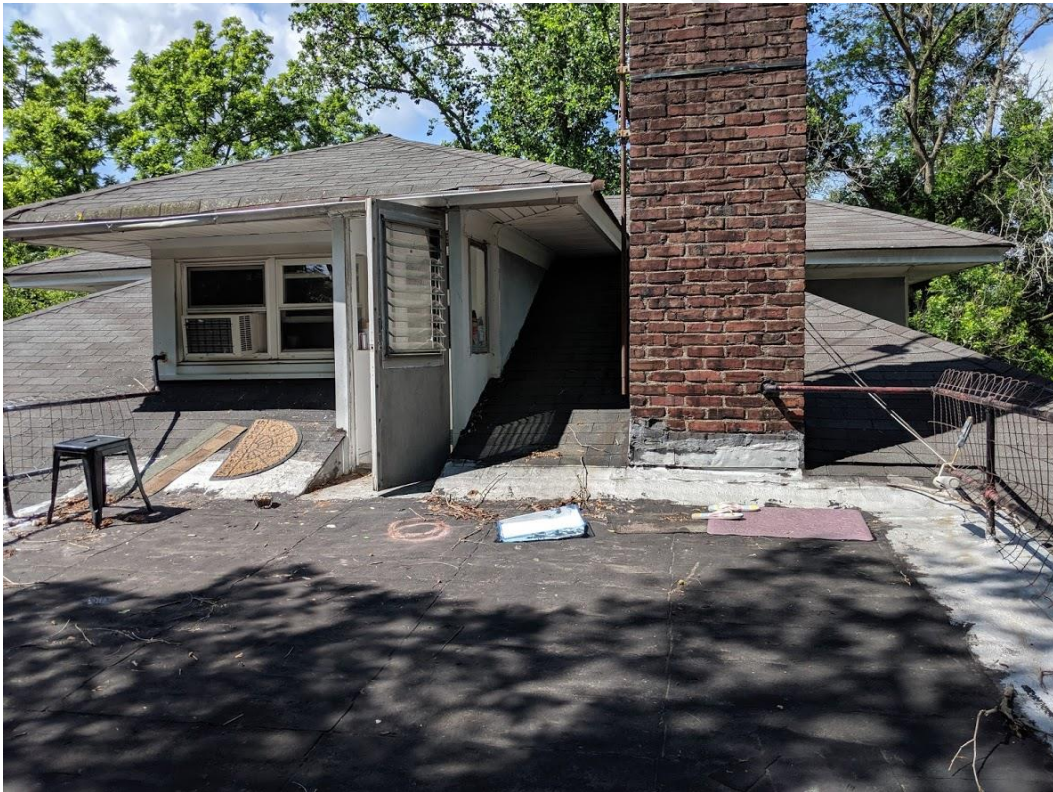
Photograph 29: Block 39 Lot 4 Roof above Northeastly Side Façade of Building

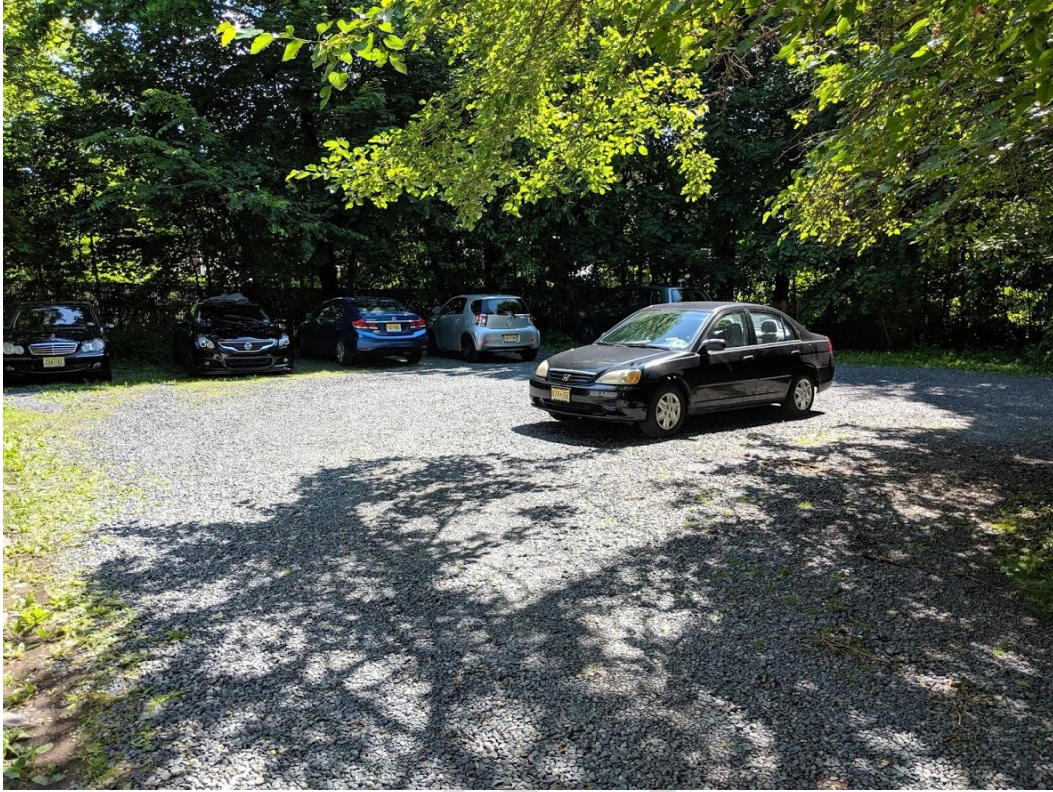
Photograph 30: Block 39 Lot 4 Parking Lot

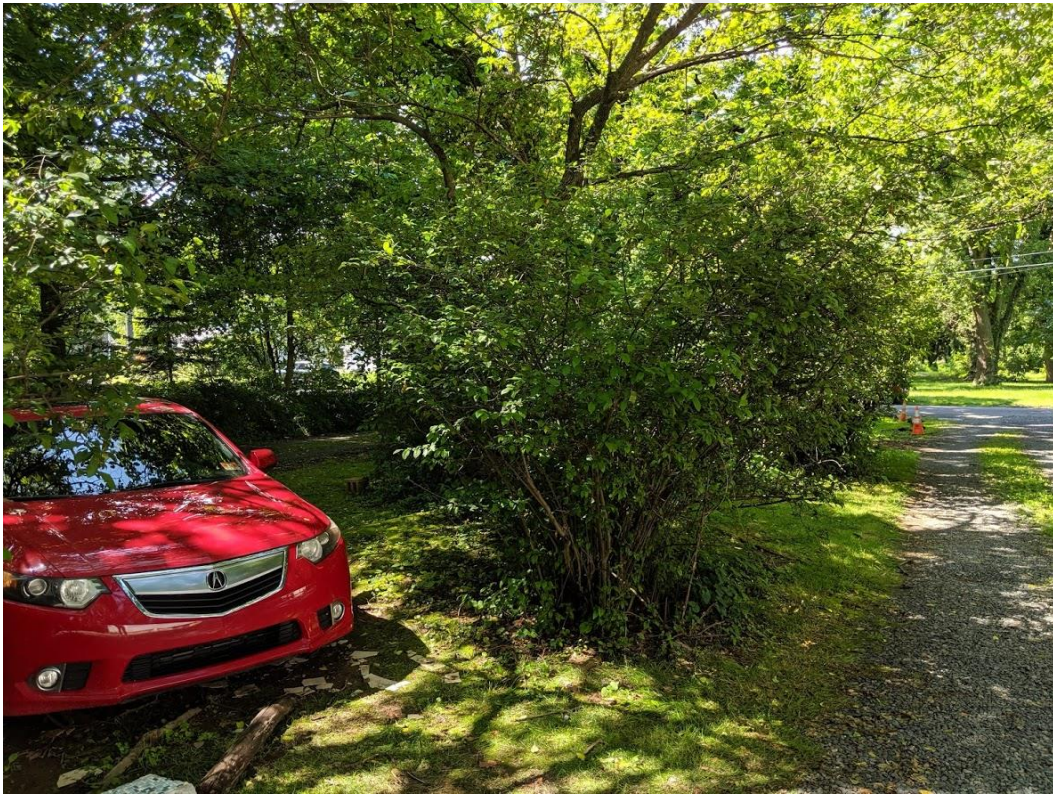
Photograph 31: Block 39 Lot 4 Parking Lot

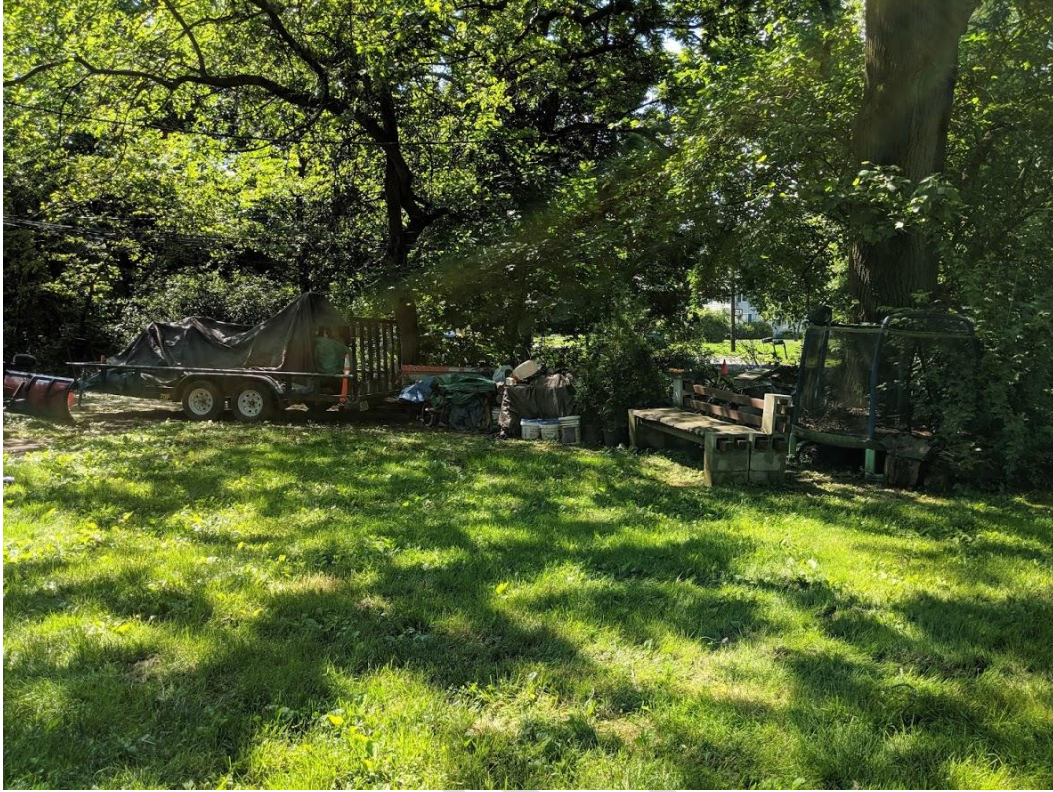
Photograph 32: Block 39 Lot 4 Westerly Side Yard

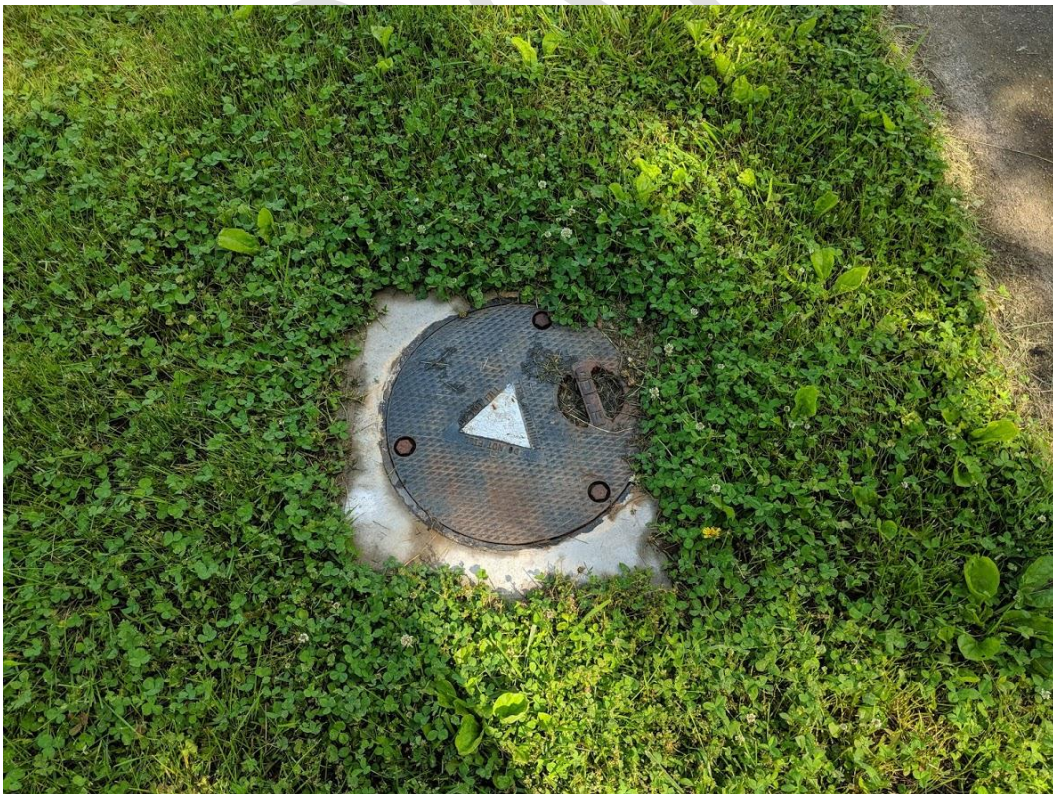
Photograph 33: Block 39 Lot 4 Monitoring Well

Furthermore, the site is included in a CEA. The source of this contamination is from adjoining Block 39 Lot 27.

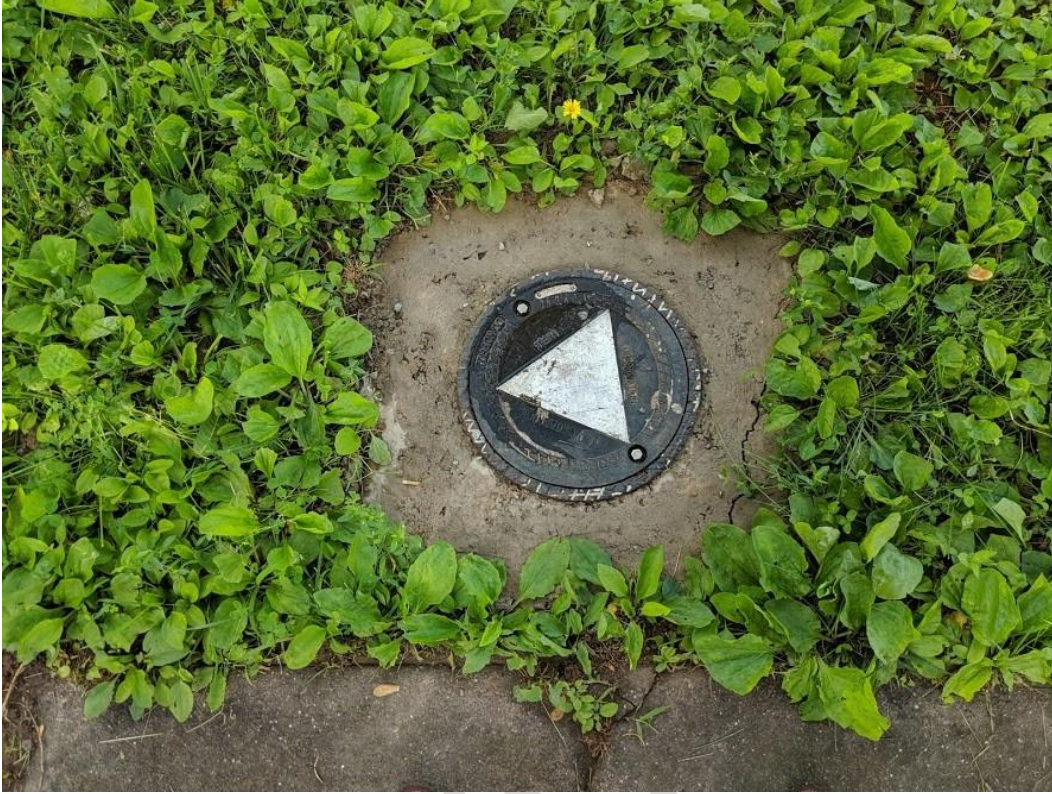
Photograph 34: Block 39 Lot 4 Monitoring Well

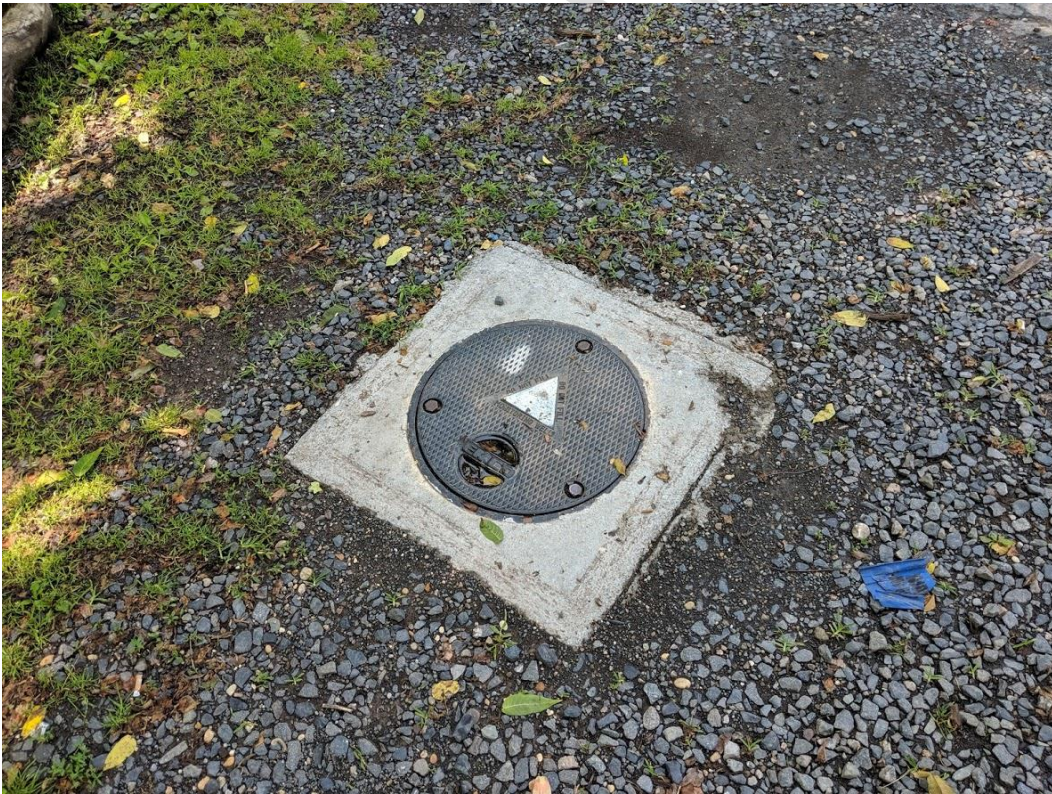
Photograph 35: Block 39 Lot 4 Monitoring Well
