Route 1 Penns Neck

Area in Need of Redevelopment Study

Draft Version 1.0 (07/03/19) Township of West Windsor | Mercer County, New Jersey

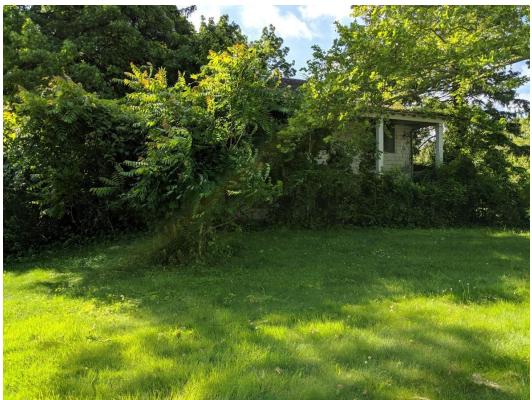
Photograph 3: Block 38 Lot 2 Northerly Corner, Looking South

Address:	3702 Brunswick Pike
Owner(s):	Penns Neck Access, LLC
Area (ac):	0.53
Property Classification:	2 (Residential)
Zoning District:	R-20
Property Use:	Vacant Dwelling
Building Description:	Dilapidated 2-Story Residential and Remnants of Garage
Permitted Use(s):	Yes
Exterior Condition:	Very Poor

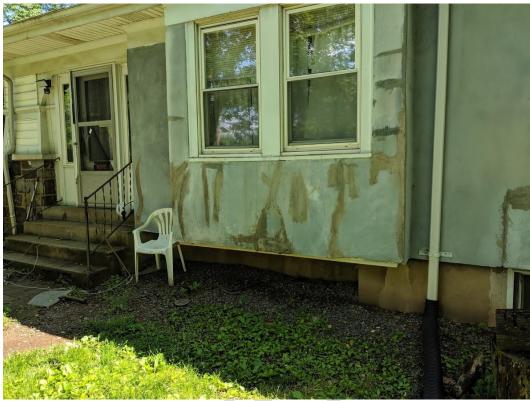
Complaints/Violations			
Date	Department	Complaint/Issue	Description
			Complaints focused on:
03/17/99	N/A	Letter from Tenants	• Construction resulting in large exterior cracks, reaching from the base of apartment 2 to the top of apartment floor. Cement used to cover these cracks, but it too is now cracking. In addition, extensive cracks have appeared on the interior walls .
			 Disruption of service including hot/cold water, gas, phone, cable
		\sim	Construction beginning before 8:00 am
03/18/99	Construction	N.J.A.C. 5:23-214.(a) Work Performed Without a Permit	Owner/Agent has conformed with requirements, all outstanding penalties satisfied
03/23/99	Construction	Violation of N.J.A.C. 5:23- 2.14(A) Worked Performed Without Required Permit	In regard to tanks. Owner/Agent has conformed with requirements, all outstanding penalties satisfied

Photograph 24: Block 39 Lot 4 Southwesterly Side Façade of Building (showing patchwork of cracks)

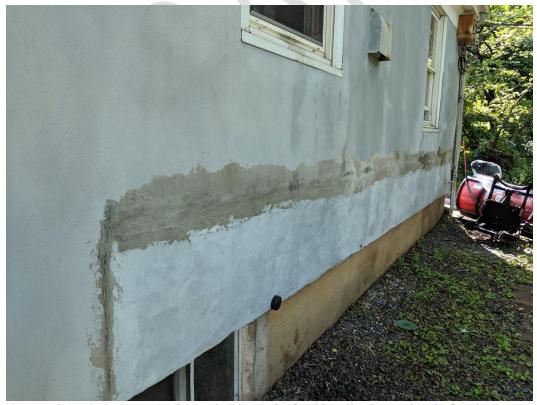
Photograph 25: Block 39 Lot 4 Southwesterly Side Façade of Building (showing patchwork of cracks)

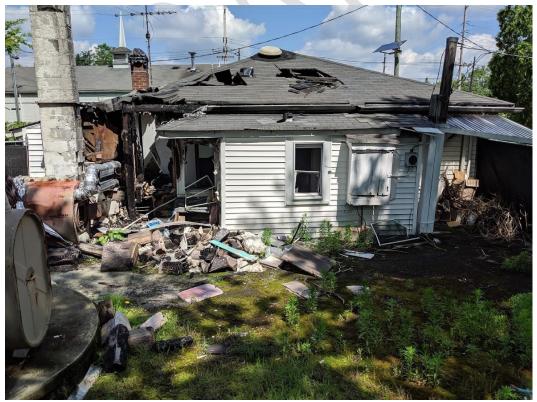
Block 38 Lot 5 is located near the northernmost portion of the Study Area and has frontage solely along Washington Road. The site is presently developed with a dilapidated and uninhabitable single-family dwelling which contained a home office for IT consulting. A fire significantly damaged the building in January of 2019, and a Notice of Unsafe Structure was issued that same month. The site is located in a CEA which is associated with adjoining Block 39 Lot 27. Pursuant to Mod IV Tax records, the structure was constructed in 1950.

Photograph 37: Block 39 Lot 5 Southerly Side Façade, Showing Fire Damage (photo taken from Lot 7)

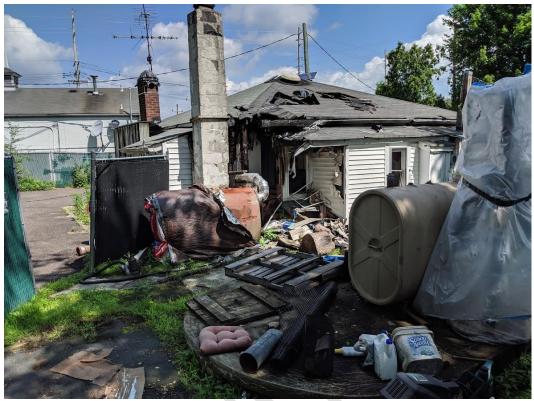
Photograph 38: Block 39 Lot 5 Southerly Side Façade, Showing Fire Damage (photo taken from Lot 7)

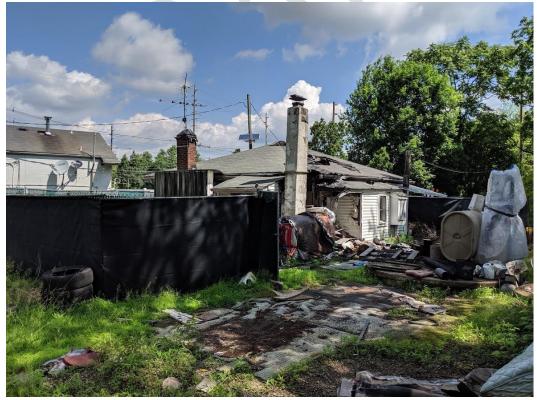
Photograph 39: Block 39 Lot 5 Rear Facade and Rear Yard, Showing Fire Damage (photo taken from Lot 7)

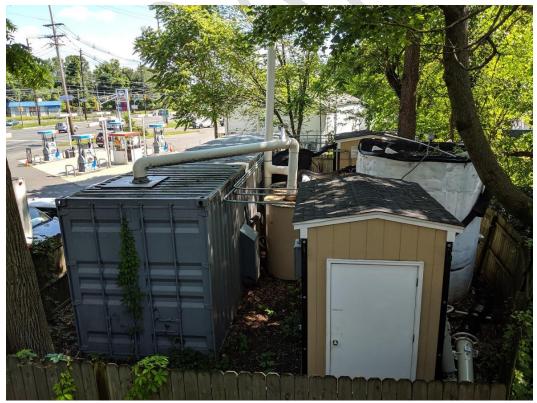
Photograph 54: Treatment Area (Photo Taken from Lot 4)

08/22/05	2005-0743	Electrical	200 AMP Service
08/22/05	2005-0743 (2)	Building	Remove (2) 750 gallon. (3) 4,000 gallon UST found during construction
11/02/09	2010-0036	Building, Electrical	Placement of treatment system with concrete pad and fence for Getty Station
