### 3.6.2: Block 38 Lot 2

## 6.2: Block 38 Lot 2

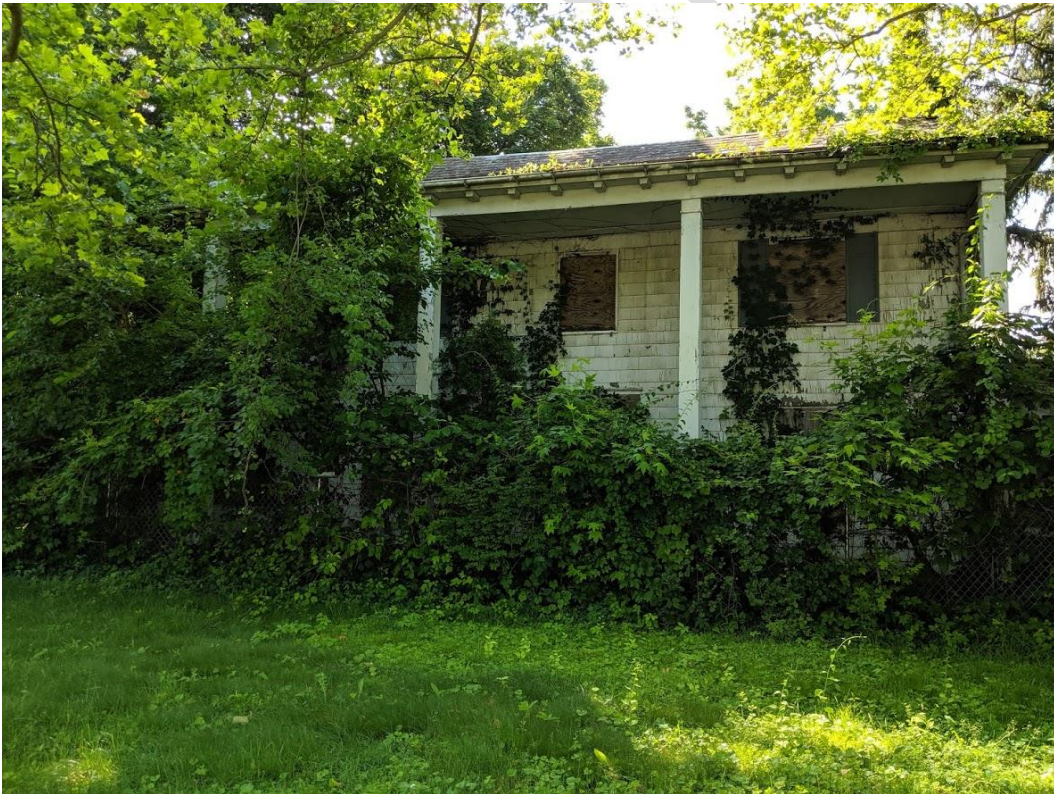
Photograph 4: Block 38 Lot 2 Front Facade of Abandoned Dwelling

Block 38 Lot 2 is located near the southwesterly portion of the Study Area and has frontage solely along US Route 1. The site is developed with a dilapidated and uninhabitable single-family dwelling. Pursuant to Mod IV Tax records, the structure was constructed in 1902.

Address:	3702 Brunswick Pike
Owner(s):	Penns Neck Access, LLC
Area (ac):	0.53
Property Classification:	2 (Residential)
Zoning District:	R-20
Property Use:	Vacant Dwelling
Building Description:	Dilapidated 2-Story Residential and Remnants of Garage
Permitted Use(s):	Yes
Exterior Condition:	Very Poor

As detailed in Section 3.6.2, this lot is presently developed with a vacant and dilapidated building. The rear portion of the building is collapsed, and the vegetation on site is overgrown. The principal building is uninhabitable in its present state. The garage area located to the rear of the building is also in disrepair.

In consideration of the above, this site meets the "a" Criterion. The existing building is clearly substandard, unsafe, and dilapidated. The site also meets the "d" Criterion, as the existing dilapidated building in its present state represents a detriment to the safety, health, morals, and welfare of the community.
