3.6.6: Block 39 Lot 4

6.6: Block 39 Lot 4

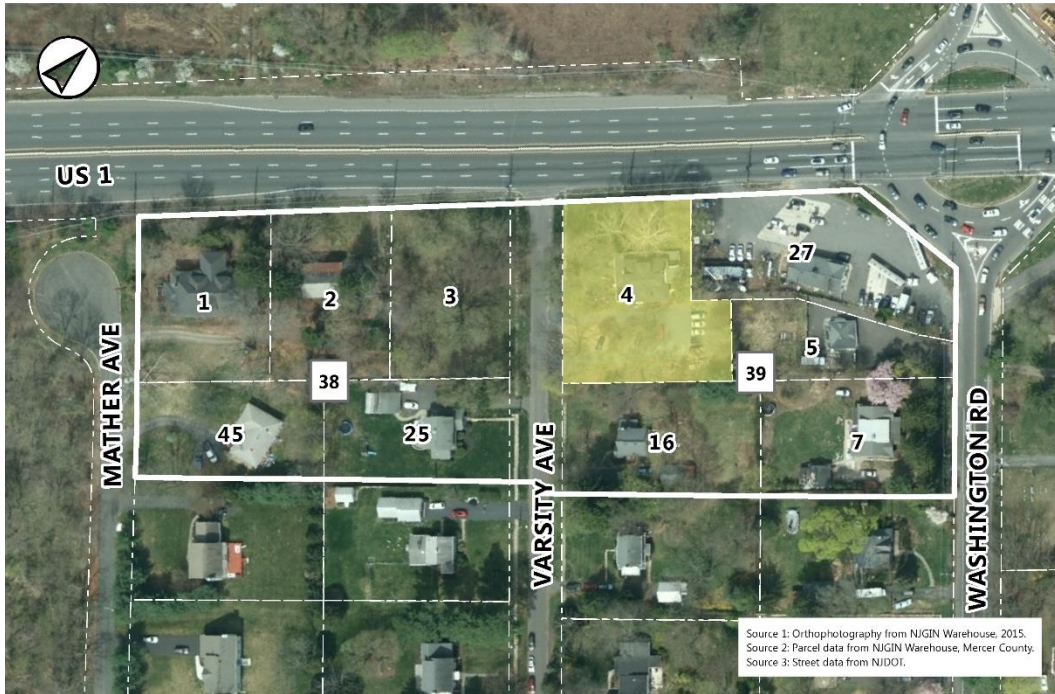
Figure 11: Block 39 Lot 4 (Scale: 1"=200')

Block 39 Lot 4 is located in the west-central portion of the Study Area at the northwest corner of Varsity Ave and US Route 1. The site is presently developed with a multifamily residential dwelling consisting of six (6) units. This development is an existing nonconforming use. The majority of the lot is located in a Classification Exception Area (CEA) which is associated with adjoining Block 39 Lot 27. Pursuant to Mod IV Tax records, the structure was constructed in 1932.
